Sanyo Service Tip

USIK / YX6E CHASSIS

TROUBLESHOOTING GUIDE

2010 MODELS

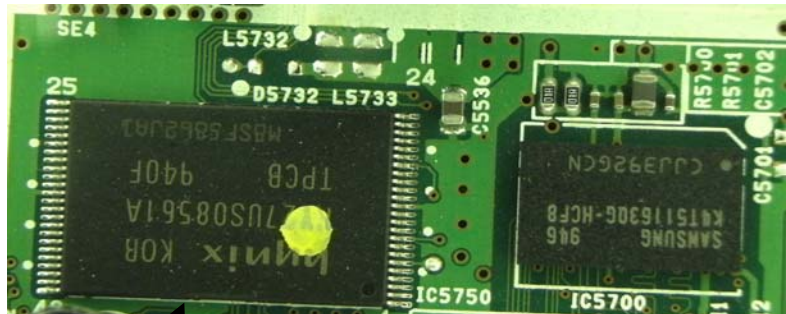
SYMPTOM: If the power LED on front of the TV is turning ON for 10-20 seconds, OFF for 1-2 second and keeps repeating, the problem is most likely IC5750A. Affected models are the 2009 & 2010 TVs (LCD and Plasma) listed.

IC5750 to be replaced

Check IC manufacture for either Samsung or Quimonda

IC5750A is located under the large shield. IC 5750A is a 48 pin NAND FLASH IC with easy access for replacement. This will fix +80% of the boards with the symptom below.

The IC 5750A you receive will have software 84 installed in it. If IC 5700's manufacture is Quimonda or TV is a 52" then the software will need to be changed with the use of a USB drive.

Note : Only use this software in the Sanyo TVs listed. If used in wrong chassis, it could cause TV not to come on and IC 5750 will need to be changed again.
